## FILTER EIGHT (TRAIN 6)

Filter 8 (train 6) is one of four 10ft x 50ft horizontal pressure filter at the Clear Creek CSD Water Treatment Plant (WTP). WTP Staff has been monitoring this filter for the last year since a decline in performance was discovered. The inside of the filter is separated into 3 individual cells. The media consists of anthracite coal, silica sand and layers of graded gravel.

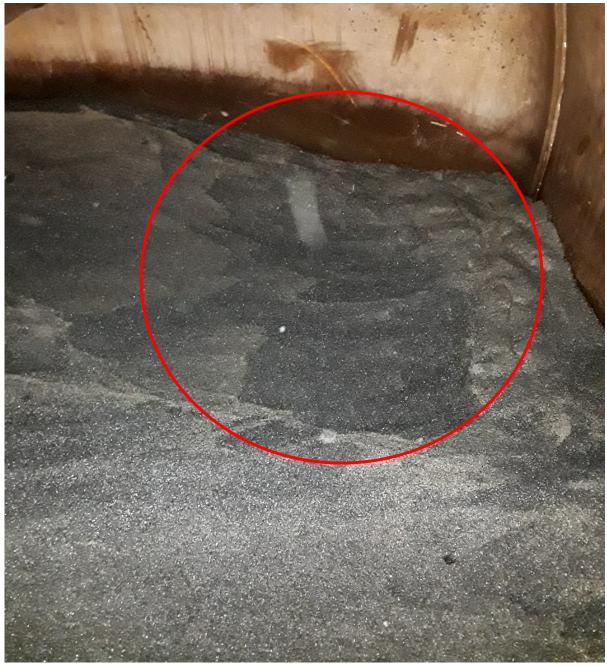
Cell A: South West corner

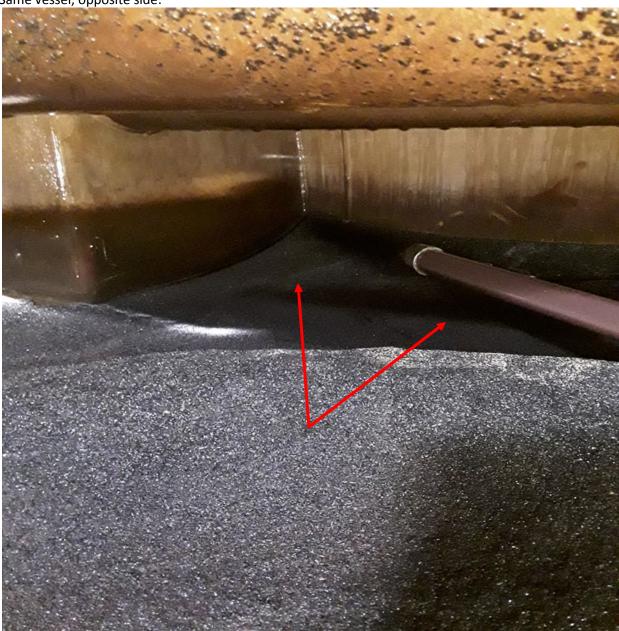
Cell A: North East corner

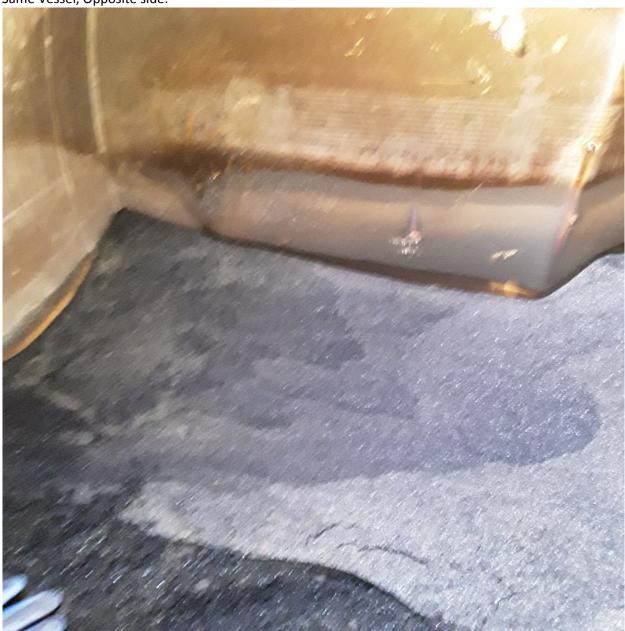
Cell A: North West corner – this area has between 5" and 9" of anthracite. Typically the average depth is 14 inches of each layer.

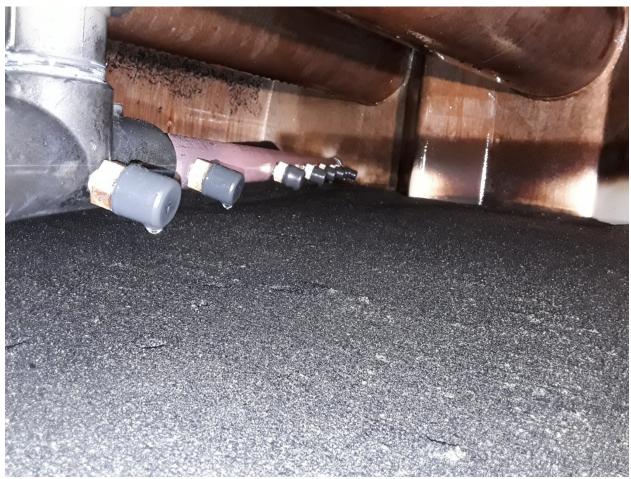
Cell B: This is the middle cell of the filter. This cell has a flat media bed and the anthracite was an acceptable distance from the centerline of the surface wash bars. An area of gravel in the sand was discovered in the middle of the cell. This could be a sign of a ruptured underdrain as well. See the below photos.

Cell B: Flat bed with 2" to 3" to the centerline of surface wash arms.

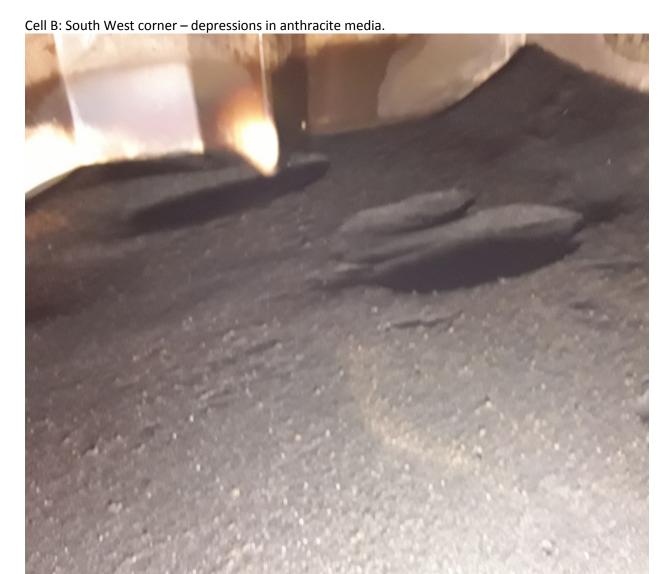
Cell B: Slight depressions in media

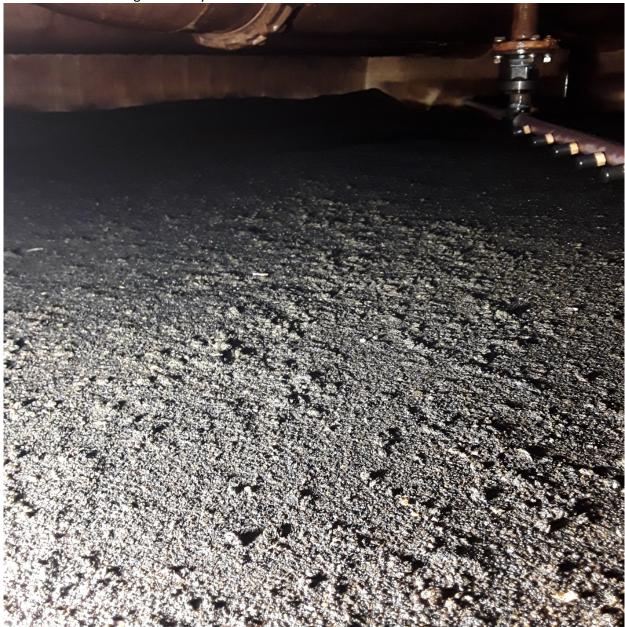
Cell B: Algae & Mudball build up.

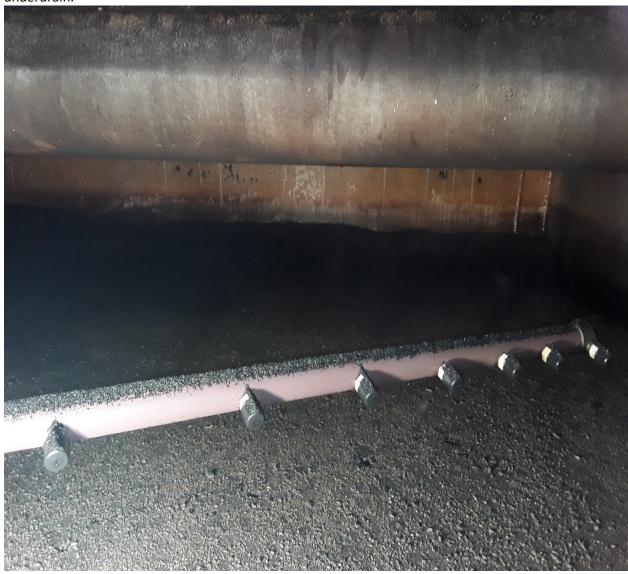
Cell C: Cell C is the cell that is farthest North, closest to dam and its condition was similar to Cell B. The bed was flat with some areas of small mudballs. The media was 3.5 to 5" from the centerline of the underdrain.

Cell C: Algae & Mudball build up.

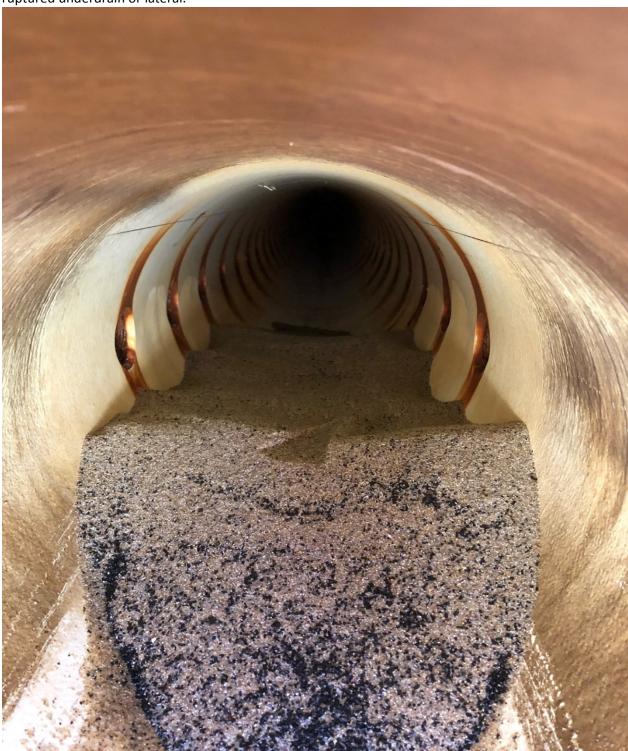
Underdrain – Train Six, Filter Eight.

Underdrain: Sand was found in the underdrain back in March of 2020 and was cleaned out. The photos below show how much sand is getting past the gravel and into the underdrain. This too is a sign of a ruptured underdrain or lateral.

Removal of material deposited into the underdrain of train 6, filter 8.

Underdrain Cleanout – Filter eight.
